CALDER RICHARDS
CONSULTING ENGINEERS

Reference: **West Jordan Elementary School Structural Evaluation**

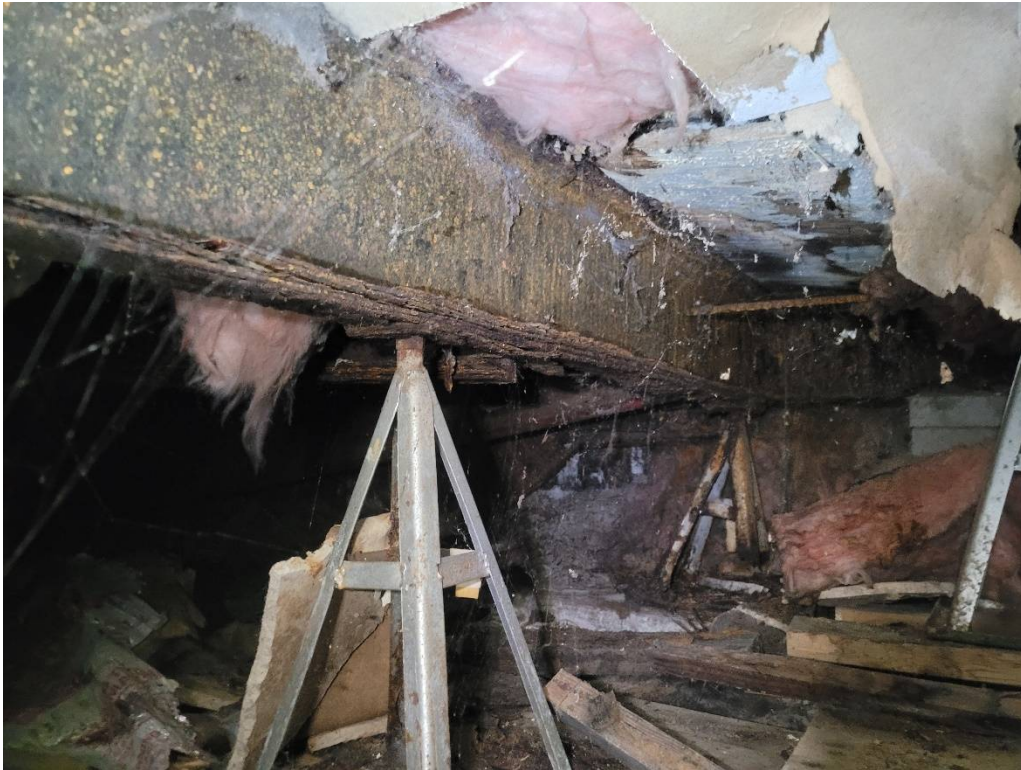
Figure 1 – steel jack supporting a steel beam, both of which have considerable corrosion. The wood framing above is unobservable, though the damage to the sheet rock may indicate water damage to the wood framing as well.

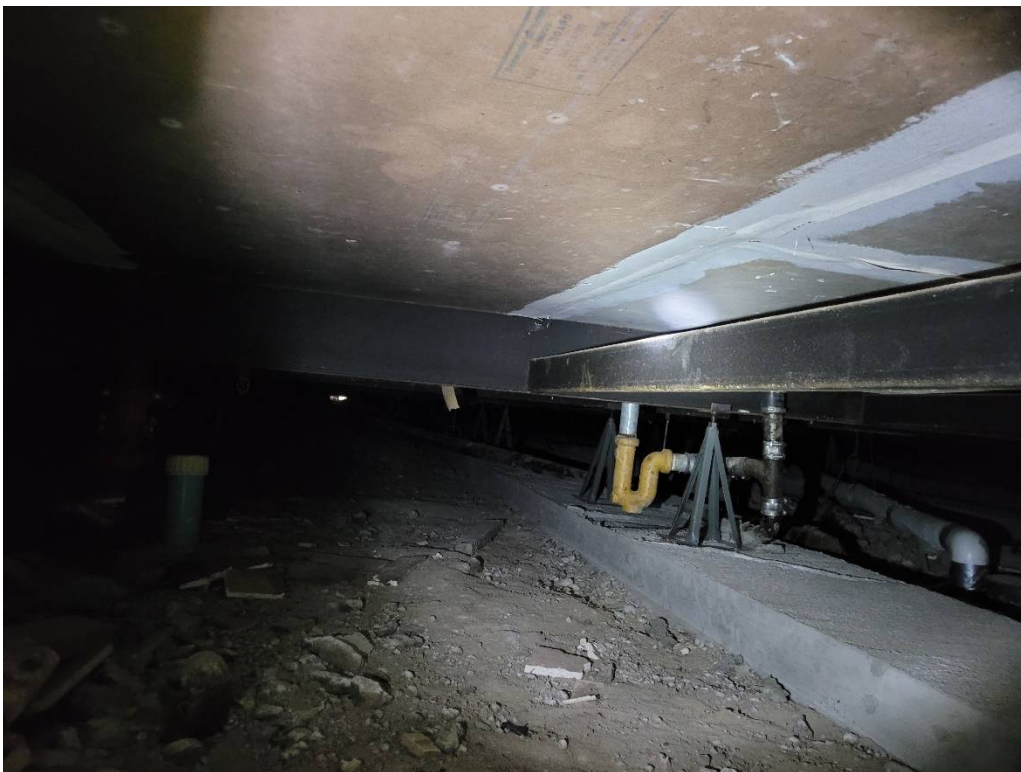
Figure 2 – an area away from the entrances where the steel framing and jack supports are in considerably better condition, though some light corrosion is observable in the top and bottom of the steel beam to the right.

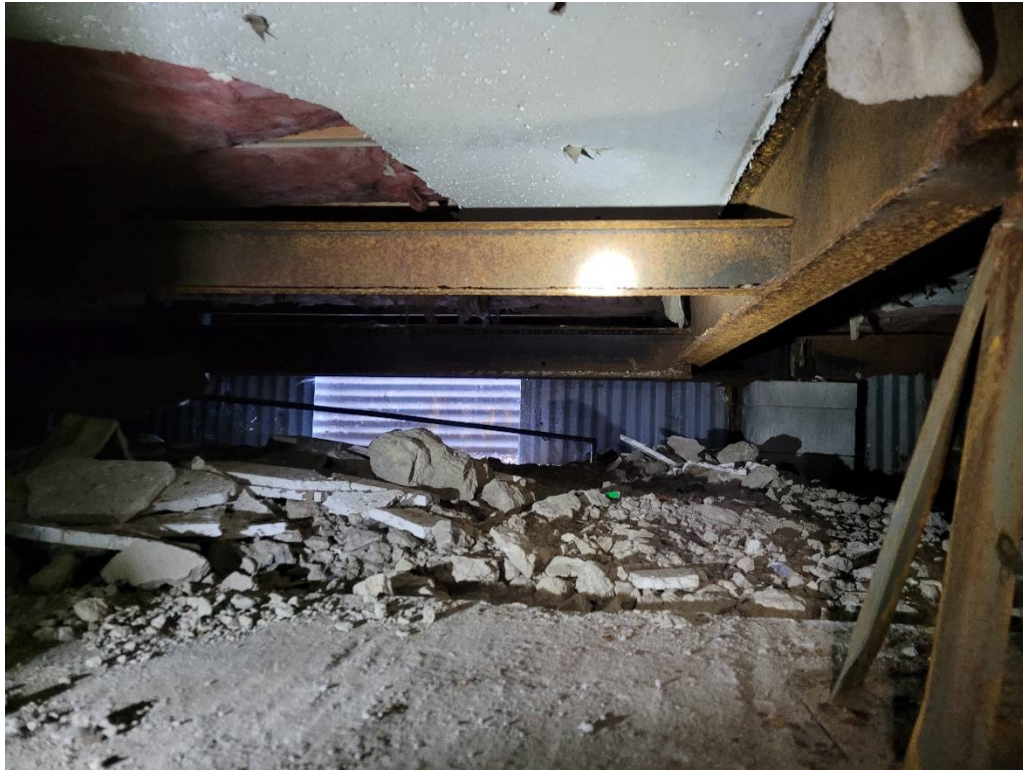
Figure 3– another area close to an entryway with considerable corrosion.

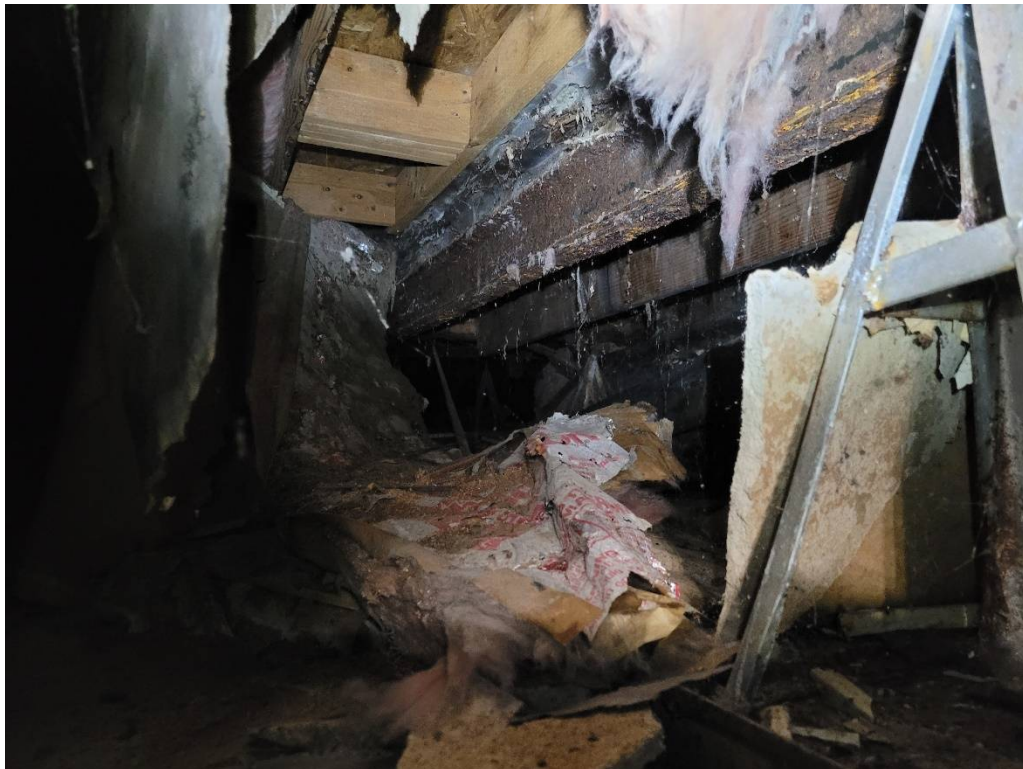
Figure 4 – an area near the entrances where the wood joists have considerable deterioration.
